29-632

Saab steering wheel control interface

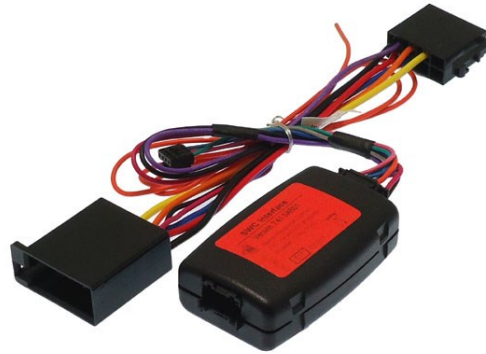
Supported functions

Volume up
Volume down
Seek/track up
Seek/track down
Source

Connection instructions

Connect the head unit specific patch lead to the interface first. If using a universal patch lead, check it is setup correctly. Refer to the diagrams overleaf to check the patch lead is correct.

Connect the ISO connectors and patch lead to the new head unit.

Identify the steering wheel control signal wire under the steering column. This will be a wire that rests at 4.5V on a 2 or 3 way connector. This voltage will fluctuate when buttons are pressed on the steering wheel.

Connect the loose orange wire from the interface to this steering control wire under the steering column.

Connect the 29-632 harness to the vehicle harness.

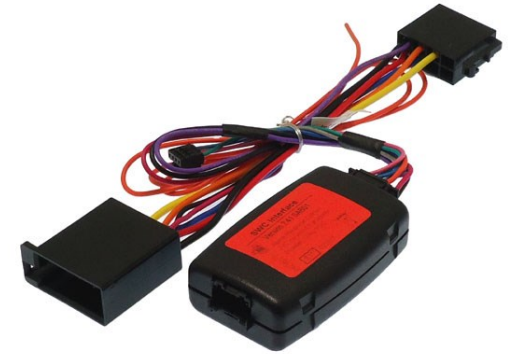
Supported functions

Volume up
Volume down
Seek/track up
Seek/track down
Source

Connection instructions

Connect the head unit specific patch lead to the interface first. If using a universal patch lead, check it is setup correctly. Refer to the diagrams overleaf to check the patch lead is correct.

Connect the ISO connectors and patch lead to the new head unit.

Identify the steering wheel control signal wire under the steering column. This will be a wire that rests at 4.5V on a 2 or 3 way connector. This voltage will fluctuate when buttons are pressed on the steering wheel.

Connect the loose orange wire from the interface to this steering control wire under the steering column.

Connect the 29-632 harness to the vehicle harness.
